Manhole Inspection Summary

Manhole # S67Q__008MH

Insp Date: **5/15/08 9:07 AM**

Location Address: **1525 Charlotte Ave.**

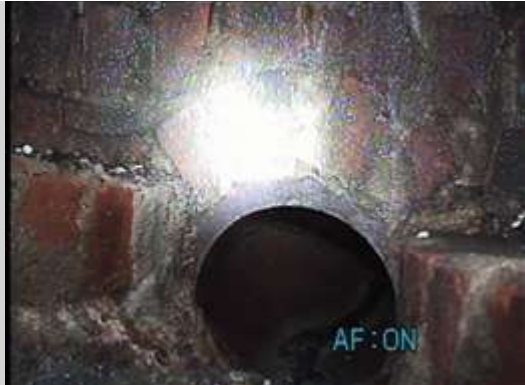
12 O'Clock Outflow

8 in. Circular Gravity Sewer
Pipe Out @ 12 O'Clock

Pipe Height: **8.4** (in.) Rod and Bar (Angled)
Pipe Material: **Clay** ☐ Pipe Lined
Invert Depth: **9.92** (ft.) Flow Characteristics: **Slow**
Deposits: ☒ None ☐ Mud ☐ Sludge ☐ Debris ☐ Grease
Silt Depth: (in.) Deposits Extent:
Infiltration: **None** Pipe Seal Cond: **Sound**

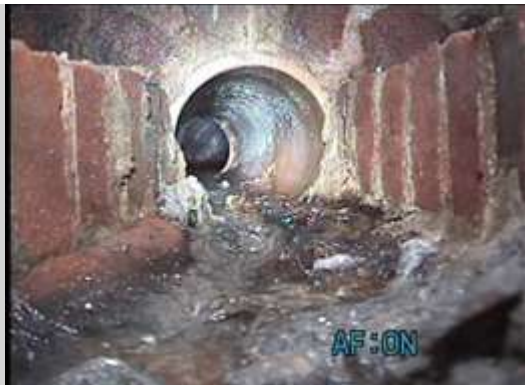
3 O'Clock Inflow

6 in. Circular Gravity Sewer
Drop In @ 3 O'Clock

Pipe Height: **6** (in.) Rod and Bar (Angled)
Pipe Material: **Clay** ☐ Pipe Lined
Invert Depth: **9.33** (ft.) Flow Characteristics: **Slow**
Deposits: ☒ None ☐ Mud ☐ Sludge ☐ Debris ☐ Grease
Silt Depth: (in.) Deposits Extent:
Infiltration: **None** Pipe Seal Cond: **Sound**
